# MICROBIOLOGICAL RUNOFF WATER QUALITY FROM A GREEN ROOF AND IN AN OPEN STORMWATER SYSTEM

by *AMMAR HUSSAIN*<sup>1</sup> and *JUSTYNA CZEMIEL BERNDTSSON*<sup>2</sup>

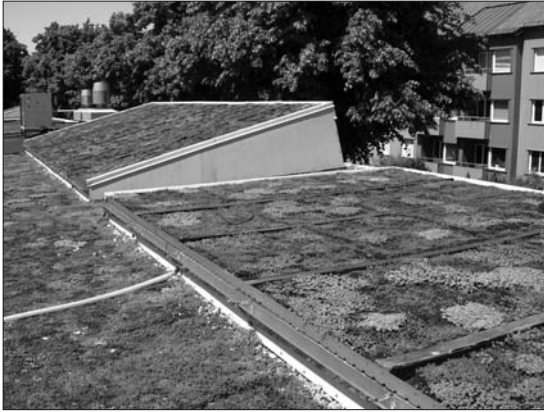
Fig. 1. Green roof – sampling point 1.

Runoff from the green roof was collected in a plastic barrel of capacity 25 l that was connected by a plastic hose to a green roof section (see Fig. 1). The barrel has been emptied and cleaned with tap water after each collection event. One grab water sample was taken from the barrel after each of the sampled precipitation events. At the other three sites (two ponds and ditch), the water samples were collected manually in plastic bottles by submerging the bottles under the water surface until the sampling bottle filled up. Sampling bottles (300 ml) were sterile and they were prepared at the laboratory ac-

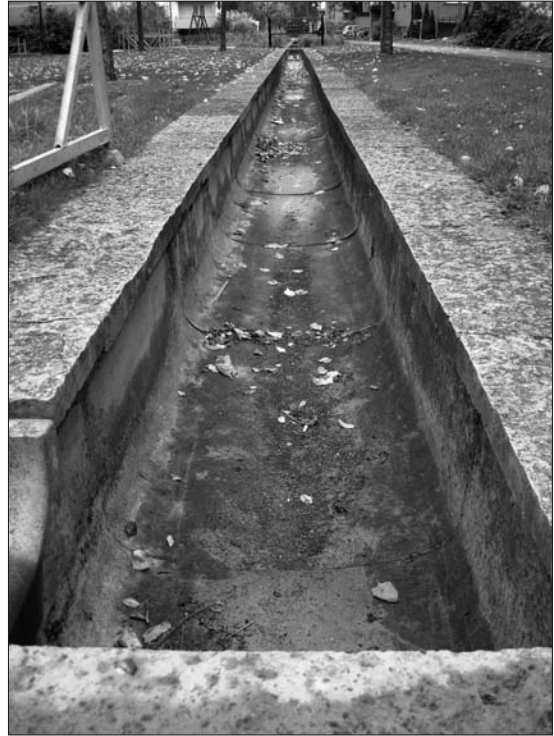
Fig. 2. Ditch – sampling point 2.

these parameters have been measured in grab stormwater runoff samples. The samples have been collected on three different occasions; 6 May, 26 October and 24 November 2009. The water samples were taken at the following four locations from the Augustenborg stormwater systems: green roof (Fig. 1), a ditch (Fig. 2), pond 1 (Fig. 3), and pond 2 (Fig. 4); one sample at each location and event. The green roof (sampling site 1) is not acces-

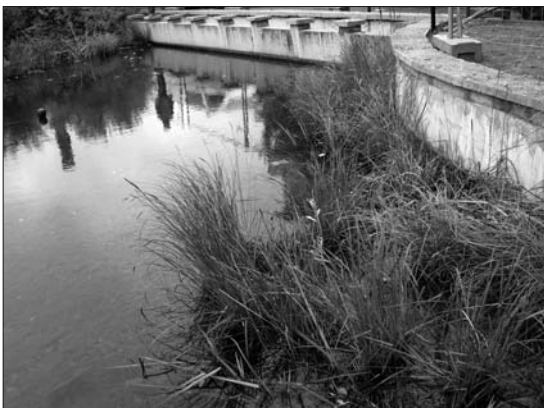
Fig. 3. Pond 1 – sampling point 3.

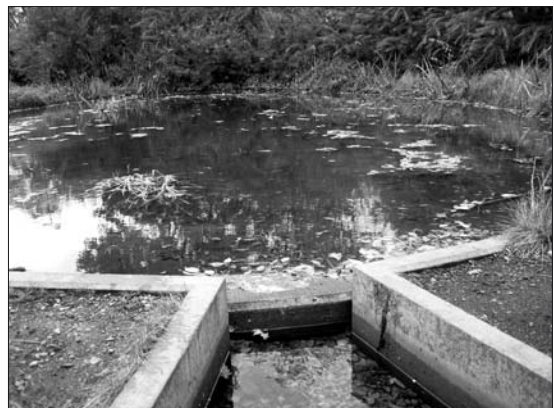
Fig. 4. Pond 2 – sampling point 4.

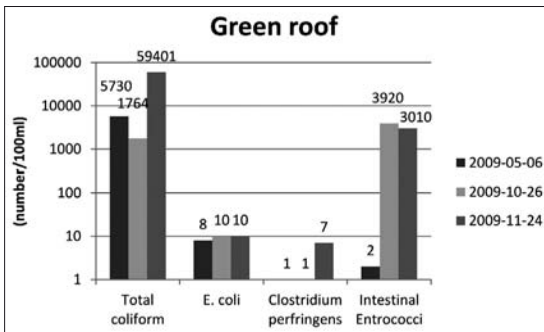
Fig. 9. Microbiological indicators (in number/100 ml, Pres. Clostridium perfringens in CFU/100ml) in stormwater runoff samples from the green roof.

When comparing the stormwater quality between the four sampling sites it is generally seen that the most polluted runoff is found at the ditch while the least polluted stormwater is found in the pond 1 followed by the runoff from the green roof. The open ditch situated in the residential area remains dry in periods between rains. It may collect dirt and garbage and cause higher pollution of first portion of runoff: dilution effect may be less in dry elements of open stormwater system than in wet ones. On the other hand, the pond 1 is designed and maintained to be wet in all kinds' of weather (in dry periods the pond is filled with water from mains supply). The stormwater in the pond 1 is circulated in a system of two ponds and a channel and aerated in a water fountain. This management is possibly contributing to water treatment and in effect lowest level of microbiological indicators.

Recall that the first sampling took place directly after an intense precipitation event of 8.8 mm and two other samplings were done after smaller rain events occurring during two days preceding sampling (in total about 6 mm). For the sampling points the ditch and the pond 1, the data show no relation between the bacterial indicators and the type of preceding precipitation. For the pond 2, which is situated downstream in the system, it is seen that the pollution load regarding all indicator bacteria is highest after the largest precipitation event during the first sampling occasion. This is similar to results of other studies (Jacobs and Ellis 1991, Characklis et al. 2005, Malin et al. 2009), showing that there is a general relation between the size of a precipitation event and the bacterial contamination of stormwater; a larger storms tend to create a more polluted runoff. At the green roof sampling station an unexpected result is obtained for the parameter intestinal *Enterococci*; the more intense rain during the first sampling occasion resulted in intestinal *Enterococci* being almost non present in runoff while the less intense precipitation events on preceding days for the second and third sampling occasions result in similar concentrations of intestinal *Enterococci* in roof runoff water. From this result it is seen that the larger rain creates cleaner runoff. However, there may be other explanations of this result, for example different sampling seasons or accidental pollution occurring prior to sam-

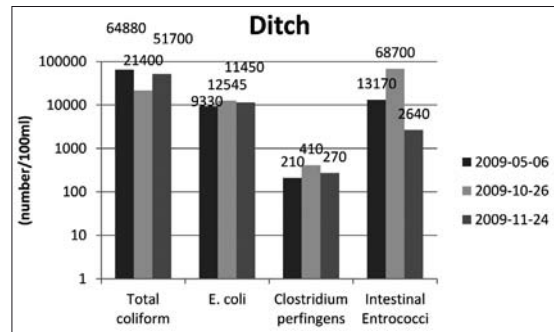
Fig. 10. Microbiological indicators (in number/100 ml, Pres. Clostridium perfringens in CFU/100ml) in stormwater runoff samples collected from the open ditch.

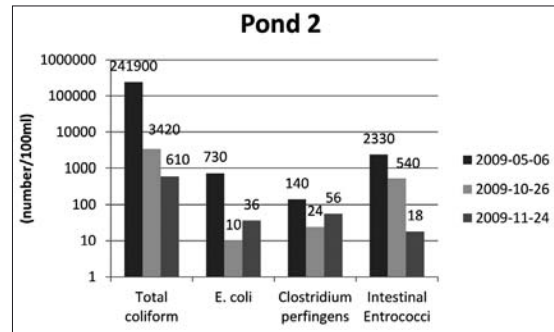
Fig. 12. Microbiological indicators (in number/100 ml, Pres. Clostridium perfringens in CFU/100ml) in stormwater samples collected from the pond 2.
