IMPACT OF SAND FENCES ON DUNE EVOLUTION AT VEJBYSTRAND

Anna Hamilton

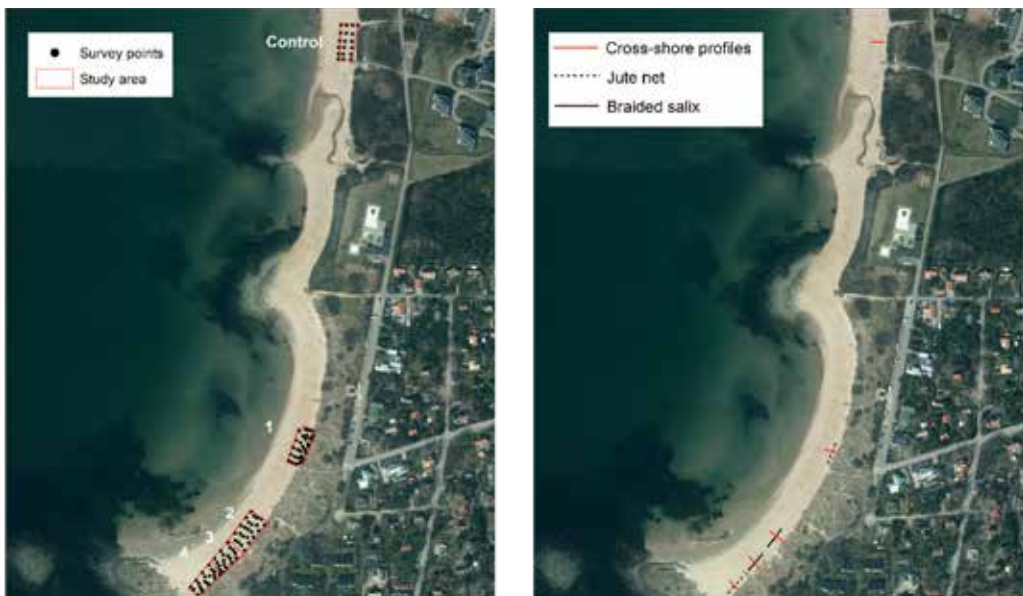
Figure 1: Sand fence sites and survey measurements are shown to the left, while the fences and the cross-shore profiles are seen in the figure on the right. Study areas stretch up to 10 m from the fence in either direction, and profiles vary between 15 and 20 m in length.

In September 2017, four sand fences were placed parallel to the dunes in the southern part of Vejbystrand to enhance dune recovery. Two different fences were constructed, one made from jute mesh netting and the other made from braided Salix. Both of these are a natural, biodegradable materials which is important when being placed so near the marine environment. The jute fence is 60 cm in height whilst the Salix fence is 120 cm. The latter was designed by Eva Thulin, a resident to Vejbystrand, who the municipality has continued collaboration with in order to monitor changes. The fences were constructed at four separate sites and are approximately 25 m long. With the exception of the first fence which is placed 100 m north of the other three, the fences are spaced within 10 m of one another. Survey measurements documenting elevation change have been taken approximately four times per year in attempt to monitor seasonal variations, though the amount of time in between measurements is varied. During the last survey in September 2019, an additional measurement was made in the north of the beach where there are no fences. The placement of the fences, as well as the measurement points and cross-shore profiles are seen in Figure 1 below.

Cross-shore profiles were drawn perpendicular to the middle of each fence in Scalgo Live. The profile placements are seen in Figure 1. The profile graphs seen in Figure 8 highlight the drastic change between 2010 and 2017, especially for fences 3 and 4. The 2017 LiDAR profiles are much steeper at the dune foot showing inundation from the recurring storms. The 2010 LiDAR profiles for fence 3 and 4 extend further seaward than the profiles at fence 1 and 2. All of the graphs show that there has been a positive progression of the profiles since 2017.

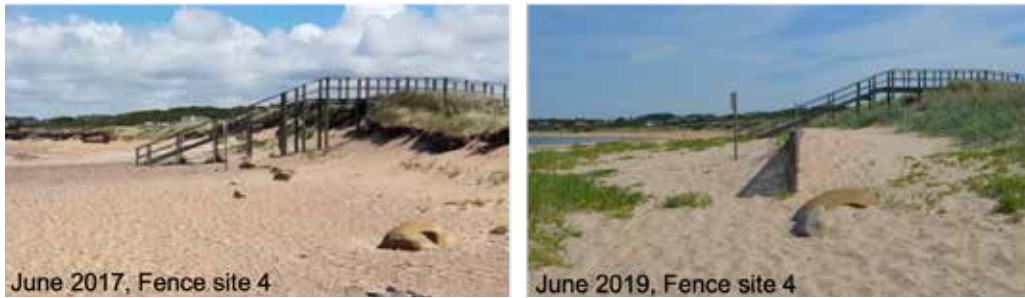
Figure 2. Photographs from the study area before (left) and 2 years after (right) the fences were set up. These photos were taken from the south side of Vejbystrand in June 2017 and 2019 respectively.

The pictures taken during the field visits show that the volume of sand around the fences has increased and the morphology and width of the dune system has changed. Figure 2 below shows the fourth fence before (left) and after (right) the fences were introduced. It is apparent that the morphology of the backshore has changed and that a difference in vegetation cover exists. This will be further expanded upon in section 5 below.

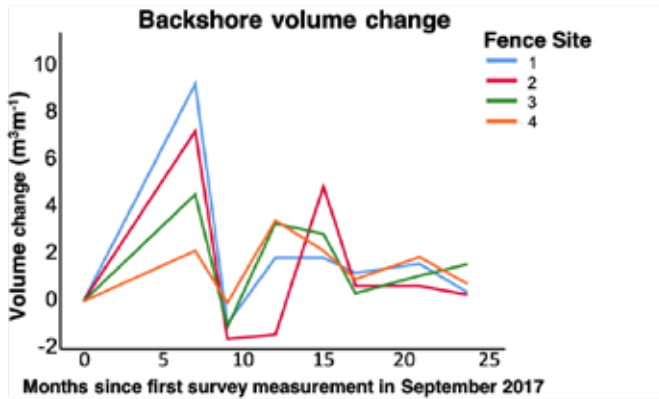
Figure 3: This figure shows the rate of volume change between each survey measurement since the first survey measurement in September 2017.

Additionally, the ANOVA test did not find any significant difference between any of the fences ($F_{3,28} = 0.081$, $p > 0.05$). Volume change was calculated between each survey measurement. Figure 3 shows the rate of change (in $\text{m}^3 \text{ m}^{-1}$) between each measurement. The initial rate in volume change between September 2017 and April 2018 is highest during the study period. Between the second measurement in April 2018, and the third meas-

urement in June 2018, all fence sites experienced a decrease in volume. By December 2018 the second fence has rapidly gained sand. Sand continues to accumulate throughout the winter season for the remaining fences but at a slower rate. Between February 2019 and June 2019, the rate of accumulation begins to increase again and is slowed down during the summer.

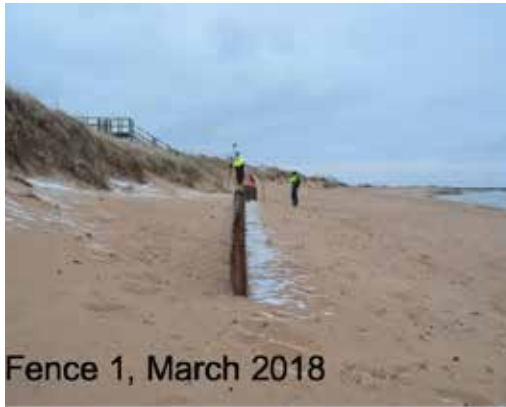
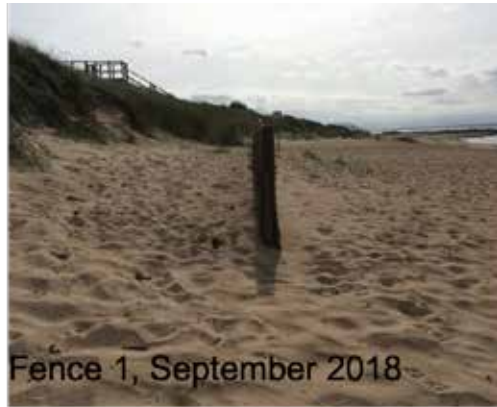
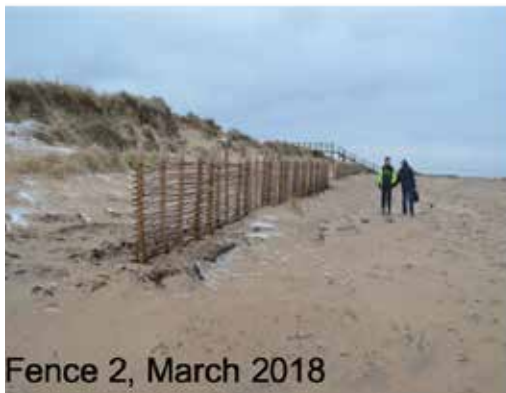
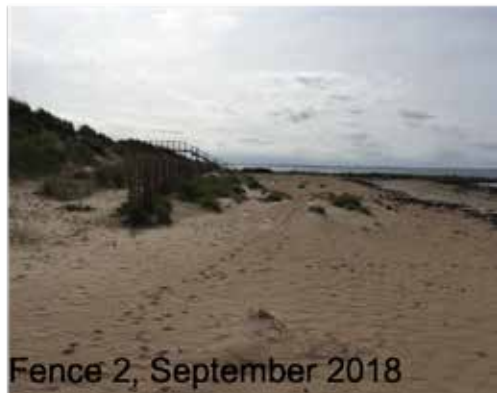
Figure 5: Pictures showing the seasonal differences in sand accumulation along the sand fences on Vejbystrand during 2018. Fence 1 in March 2018 is seen in the top left corner. The same fence is seen in September 2018 on the top right. Fence 2 in March 2019 is seen on the bottom left and the same fence is seen in September 2018 on the bottom right. The pictures taken in March are by the author and the pictures from September are taken by Geraldine Thiere, Ängelholm municipality.

The following images show the change during the first year of the study. The pictures to the left show each of the fence types in March (after a winter season) and in September (following a summer season).

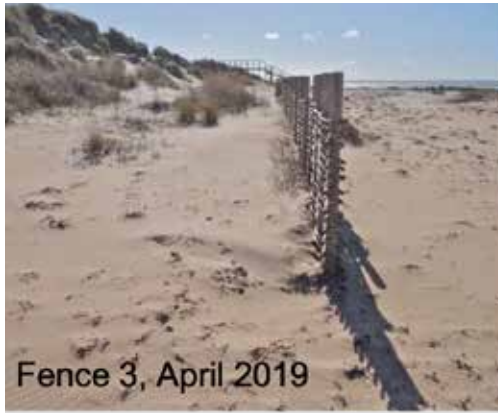
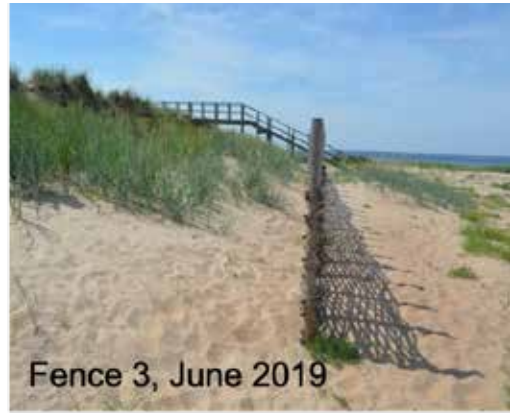
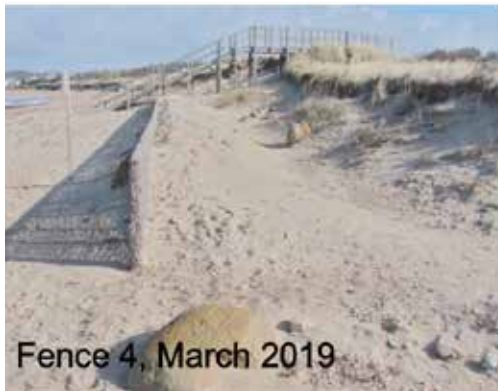
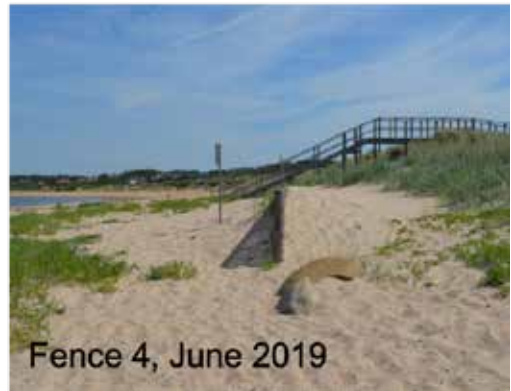
Figure 6: Pictures showing the seasonal differences in sand accumulation along the sand fences in Vejbystrand during 2019. Fence 3 in April 2019 is seen in the top left corner. The same fence is seen in June 2019 in the top right. Fence 4 in March 2019 is seen in the bottom left and the same fence is seen in June 2019 in the bottom right. The pictures taken in June are by the author and the pictures from April/March are taken by Eva Thulin, resident in Vejbystrand.

During the second year of the study period, even more drastic morphologic changes are seen:

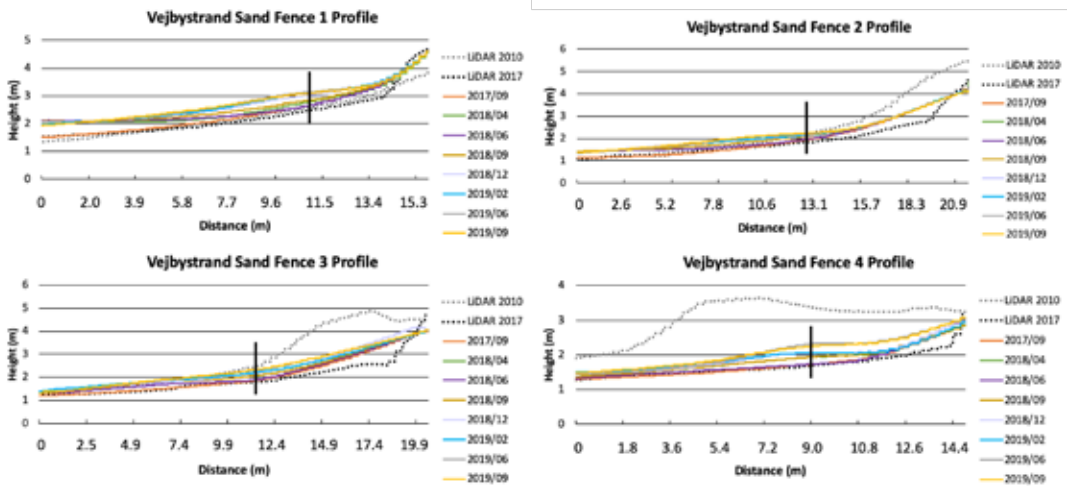
Figure 8: Vejbystrand sand fence cross-shore profile progression. The vertical black line shows the sand fence placement along the profile (height of fence is not to scale).

These results coincide well with the profiles in Figure 8 above which show drastic changes to the profiles perpendicular to fence sites 3 and 4 between 2010 and 2017, and a relatively fast recovery since the fences were implemented in 2017. Besides vegetation cover, present-day species richness was also considered. A vegetation inventory was done in June 2019 and the results are found in Table 2 below. Ten different species were found at the sites surrounding fence 1, 2, and 4, and twelve species were found at site 3. No significant difference in species richness was found. The most common beach grasses are present at all four fence areas, with other vegetation spread out randomly among the fences.

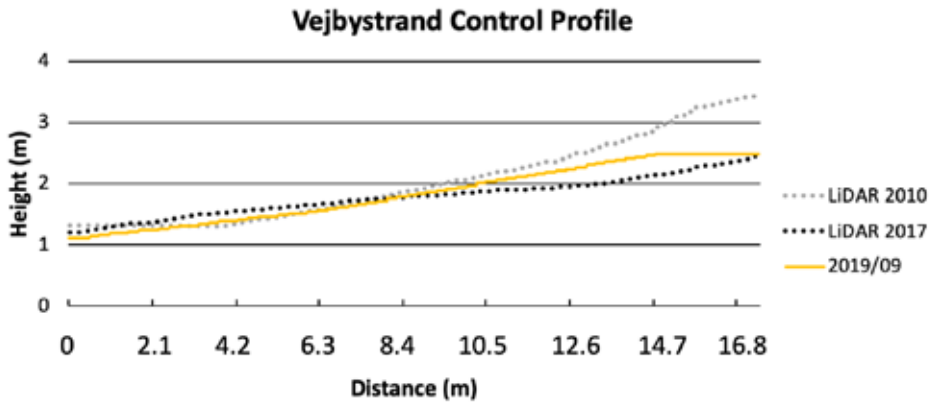
Figure 9: *Vejbystrand control site cross-shore profile*

Figure 9 below shows the profiles at the control area in the northern part of Vejbystrand. Similar to the sites with fences, the cross-shore profile at the control site eroded between 2010 and 2017 and has since begun to build up.

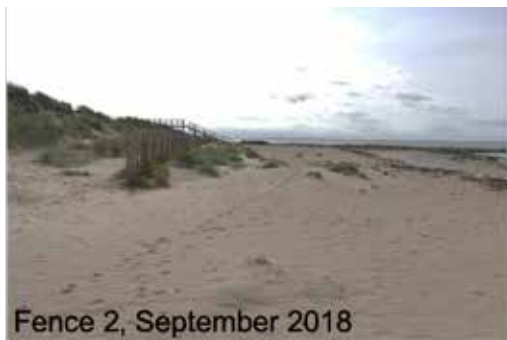
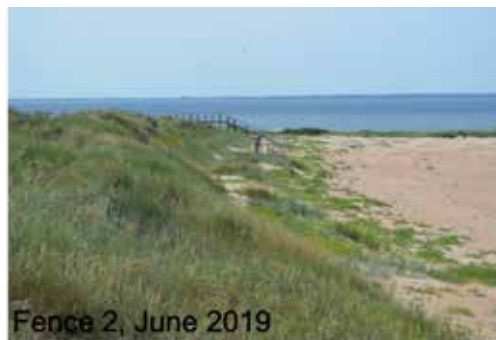
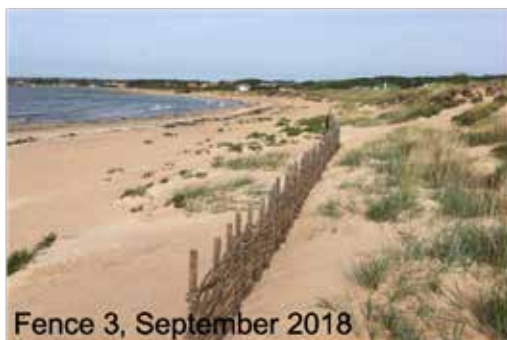
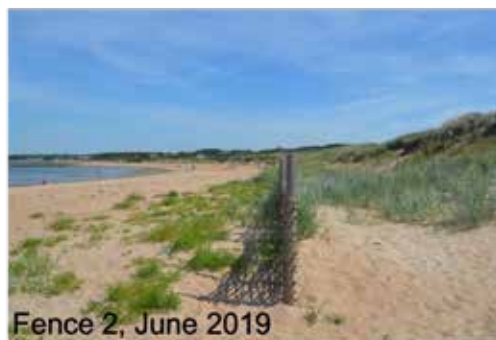
Figure 10: Pictures showing the differences in sand accumulation along the sand fences in Vejbystrand from Summer 2018-2019. Fence 2 in September 2018 is seen in the top left corner. The same fence is seen in June 2019 in the top right. Fence 3 in September 2018 is seen in the bottom left and the same fence is seen in June 2019 in the bottom right. The pictures are taken by the author.

The pictures in Figure 10 show the change after one and two summer seasons for each of the fence types. Despite seasonal differences in blooming of certain vegetation types between these two months, there is a clear increase in vegetation area.

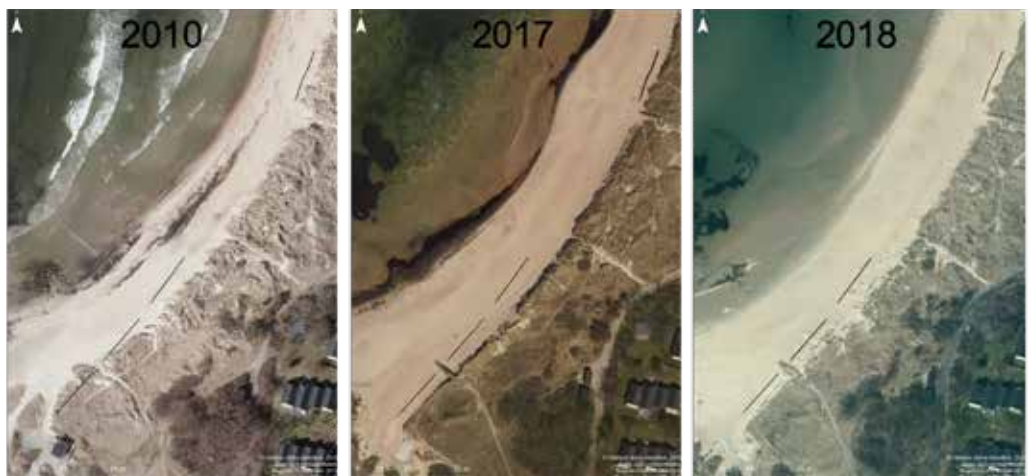
Figure 11: Sand fence placement in relation to 2010 (left), 2017 (middle), and 2018 (right) orthophotos
