SOLVING INCIDENTS WITH CONTAMINATED DRINKING WATER USING HYDRAULIC MODELLING

HYDRAULISK MODELLERING EFFEKTIVT FÖR ATT SPÅRA KÄLLAN UNDER DRICKSVATTENKRISEN

J. Barup¹, S. Steen Kronborg¹, V. Pelin¹, H. Aspegren², T. H. Persson¹, H. Lundgren¹

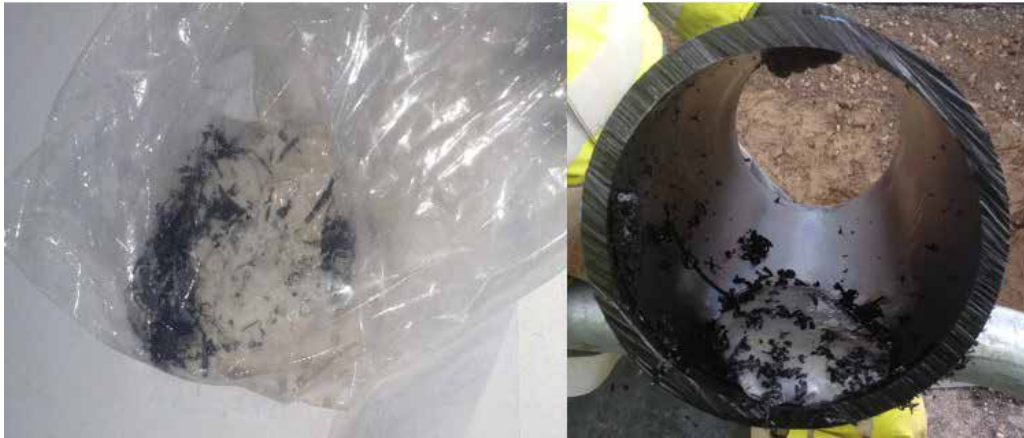
To find out why the siphon acted as the host of the contaminant a filming and pigging procedure was initiated. The film showed a white blob in the pipe (Figure 3). The white blob, with the size of an orange, was recovered when the pipe was poly-pigged and could later be identified as wheat flour with growth of *Erwinia* spp. As for the origin of the wheat flour, the main hypothesis is that it was inserted during the installation work to absorb excess water when welding the new polyethylene pipe with electrofusion fittings to the existing polyethylene pipe.

Figure 3. To the left: The white blob (later identified as wheat flour) in incident no 1 was about the size of an orange. The black chips are pieces of the cut PE-pipe. To the right: The blob from incident no 2, later identified as growth of bacteria and fungus around a paper napkin.

ging the pipe, a blob of probable organic origin was caught (Figure 3). Examinations of the blob using microscopy with phase contrast and Fourier Transform Infrared Spectroscopy (FTIR) indicated fungus and bacterial growth on a paper napkin (Werker & Bengtsson, 2018). Typing of the bacteria indicated *Serratia* spp.
